# Home survey, level 3 (building survey)

The Old Rectory, Church Lane, Ashworth Green

RK-2026-0402

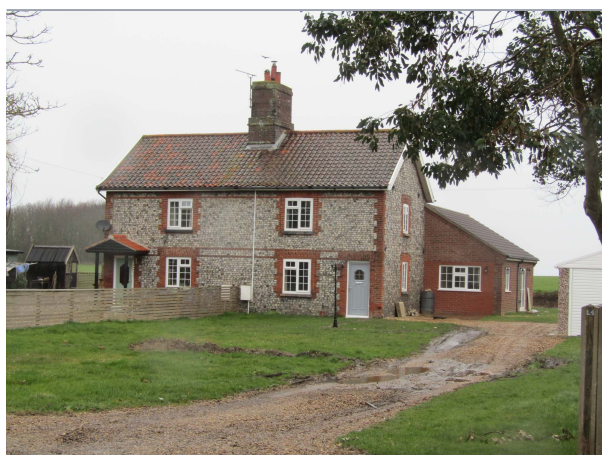
*Front elevation*

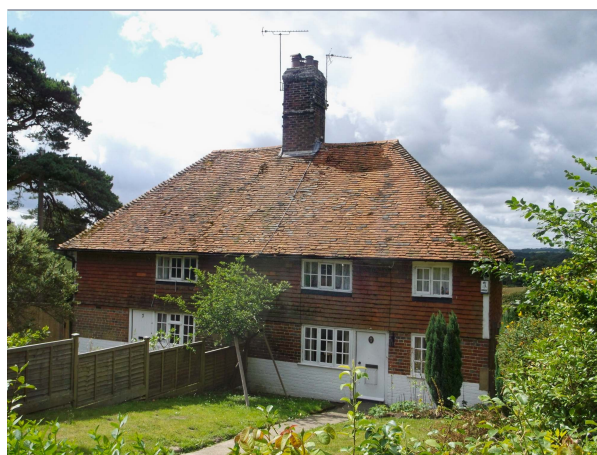
*Rear elevation and garden*

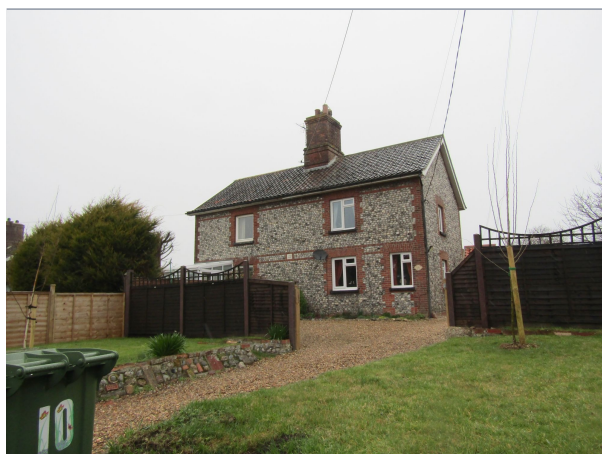
*Roof covering from the garden*

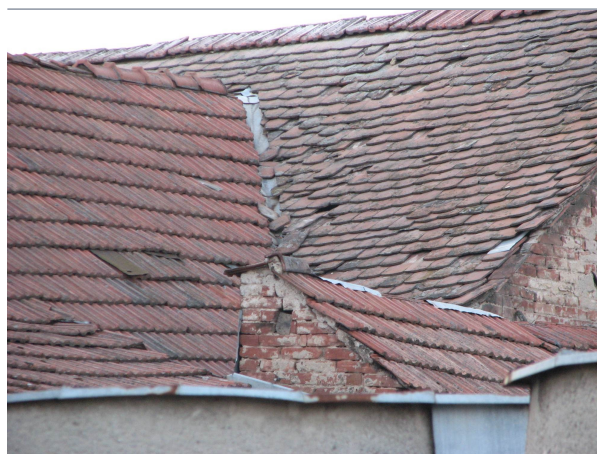
| Ref | Element | Condition / description | Cause | Rating | Photo | Recommended action | Timescale | Cost |
|---|---|---|---|---|---|---|---|---|
| 1 | D2 Roof coverings | Several slipped tiles and one missing verge tile. | | 2 | | Refix and replace tiles | Within 12 months | £ |

Pitched roofs covered with interlocking concrete tiles on timber battens over a bituminous underlay. Several tiles to the rear slope have slipped and one verge tile is missing. The coverings are otherwise serviceable for their age. Refix the slipped tiles and replace the missing verge tile; these are maintenance items caused by wind action and age of the fixings.

*Slipped tiles to the rear slope*

| Repair | Cost guidance (optional) | Guidance only |
|---|---|---|
| Refix slipped tiles, replace verge tile, repoint and re-flaunch the rear stack | £1,450 | Yes |
