# Access audit

Marlbury Civic Library, Market Walk

| Reference | RK-2026-0509 |
| Audit date | 06 May 2026 |

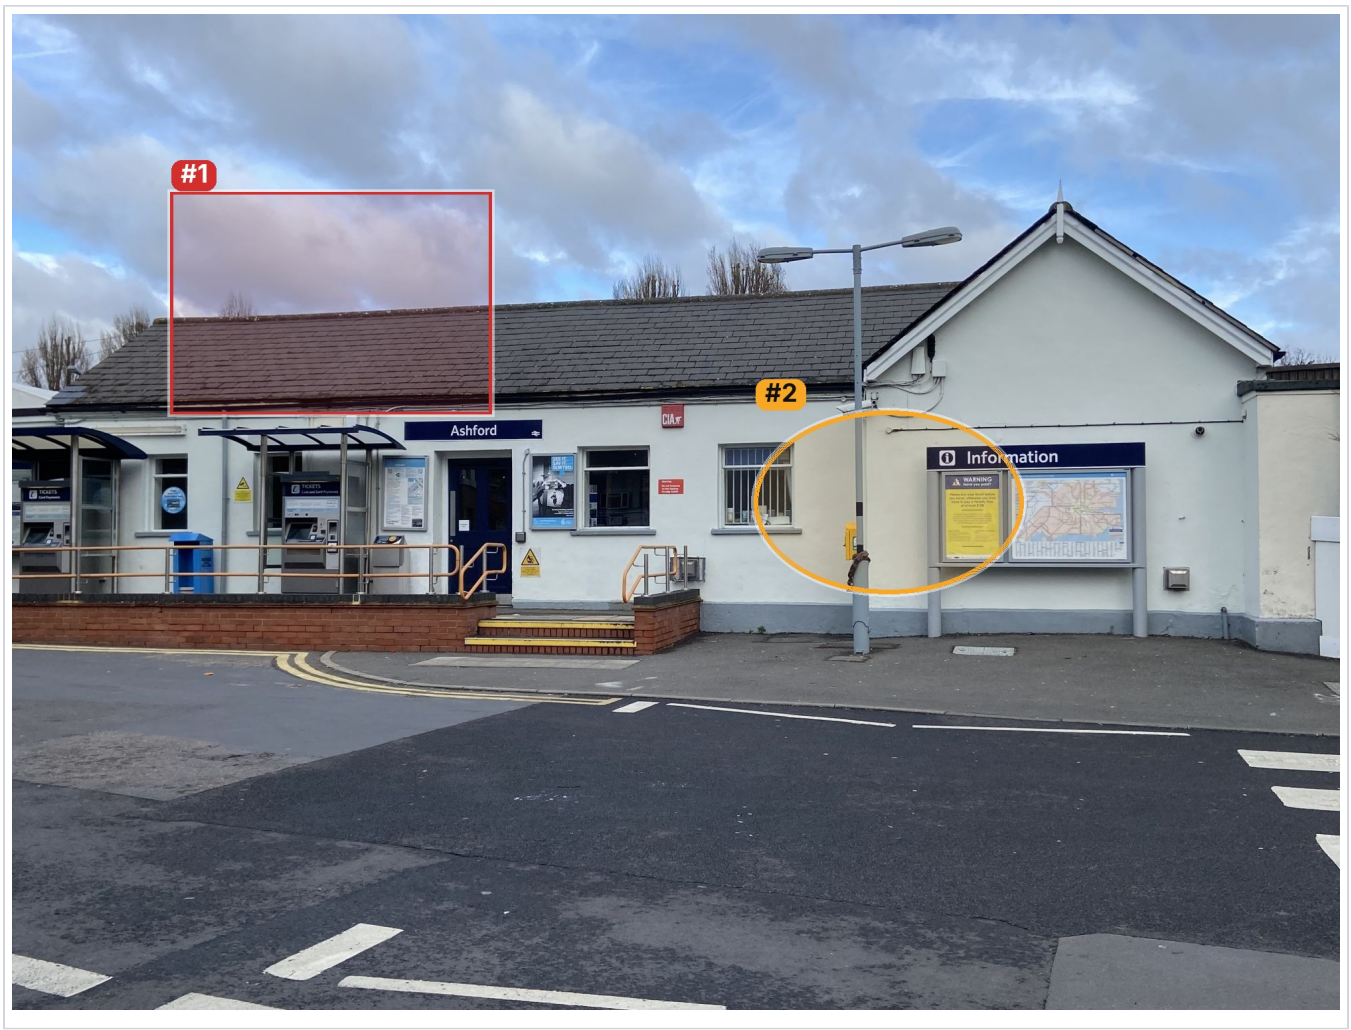
Photograph 1 — Principal entrance (arrival)

| # | Rating | Fault type |
|---|---|---|
| #1 | A | Door opening force |
| <b>Barrier:</b> 45 N opening force on the entrance doors. <b>Effect:</b> many disabled visitors cannot open the door unaided. <b>Recommendation:</b> adjust the closers to 30 N or fit a power-assisted opener. | | |
| #2 | B | Loose matting |

| # | Location | Rating | Type | Summary |
|---|---|---|---|---|
| <a href="#">#1</a> | Photograph 1 — Principal entrance | A | Door opening force | Barrier: 45 N opening force on the entrance doors. Effect: many disabled visitors cannot open the door unaided. Recommendation: adjust the closers to 30 N or... |
| <a href="#">#2</a> | Photograph 1 — Principal entrance | B | Loose matting | Replace the loose coir mat with recessed matting. |

| # | Rating | Fault type |
|---|---|---|
| Replace the loose coir mat with recessed matting. | | |

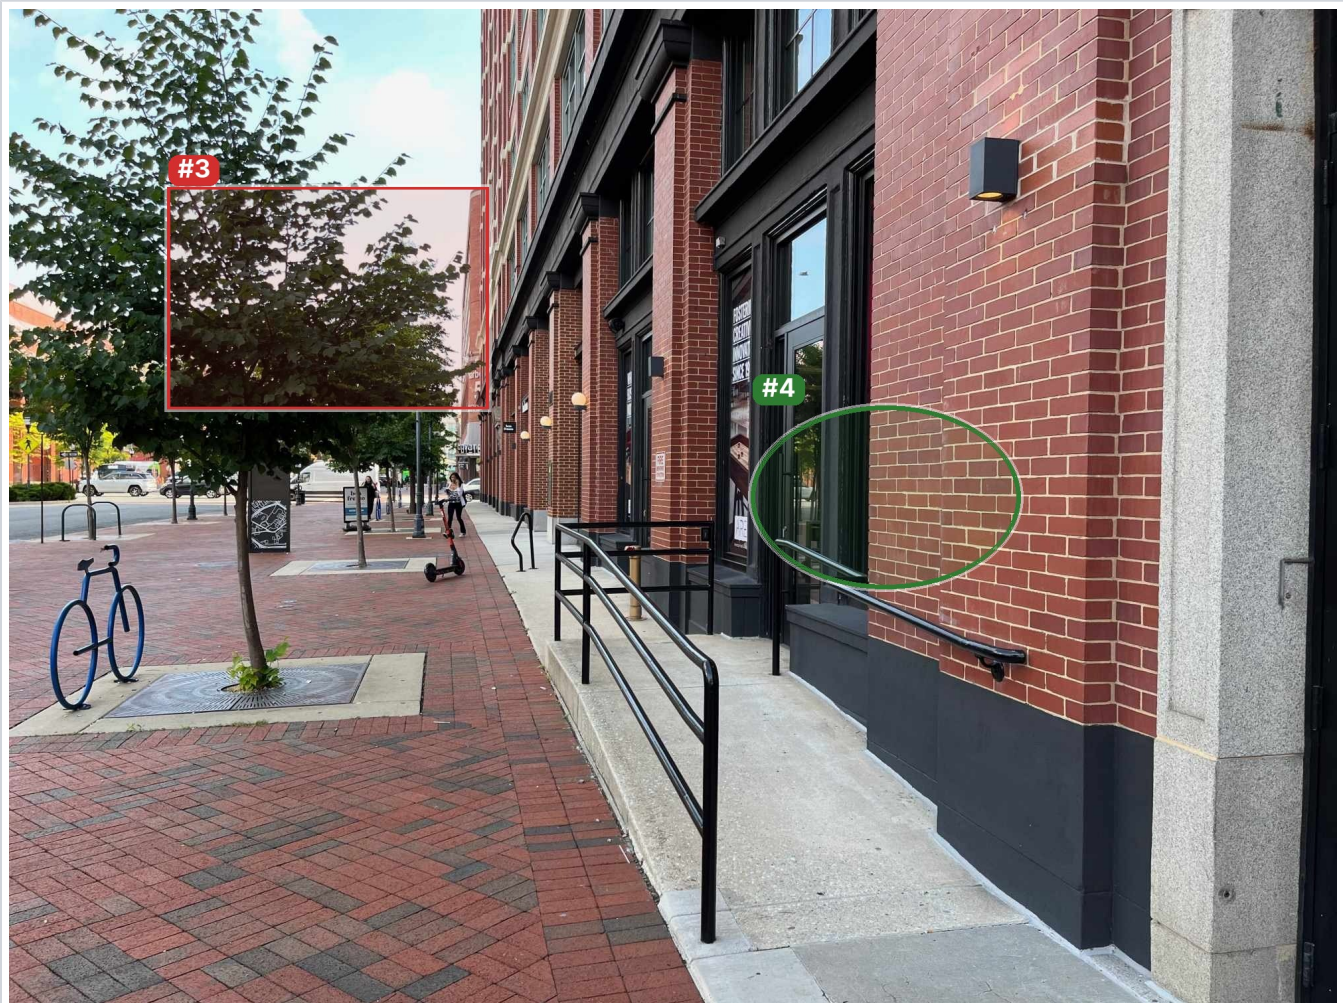
## Photograph 2 — External steps and ramp (approach)

| # | Rating | Fault type |
|---|---|---|
| #3 | A | Step nosings |
| <b>Barrier:</b> nosings not visually contrasted and a handrail on one side only. <b>Recommendation:</b> fit 55 mm contrasting nosings and a second handrail. | | |
| #4 | C | Obstruction |

| # | Location | Rating | Type | Summary |
|---|---|---|---|---|
| <a href="#">#3</a> | Photograph 2 — External steps and ramp | A | Step nosings | Barrier: nosings not visually contrasted and a handrail on one side only. Recommendation: fit 55 mm contrasting nosings and a second handrail. |
| <a href="#">#4</a> | Photograph 2 — External steps and ramp | C | Obstruction | Relocate the cycle stands clear of the path. |

| # | Rating | Fault type |
|---|---|---|
| Relocate the cycle stands clear of the path. | | |

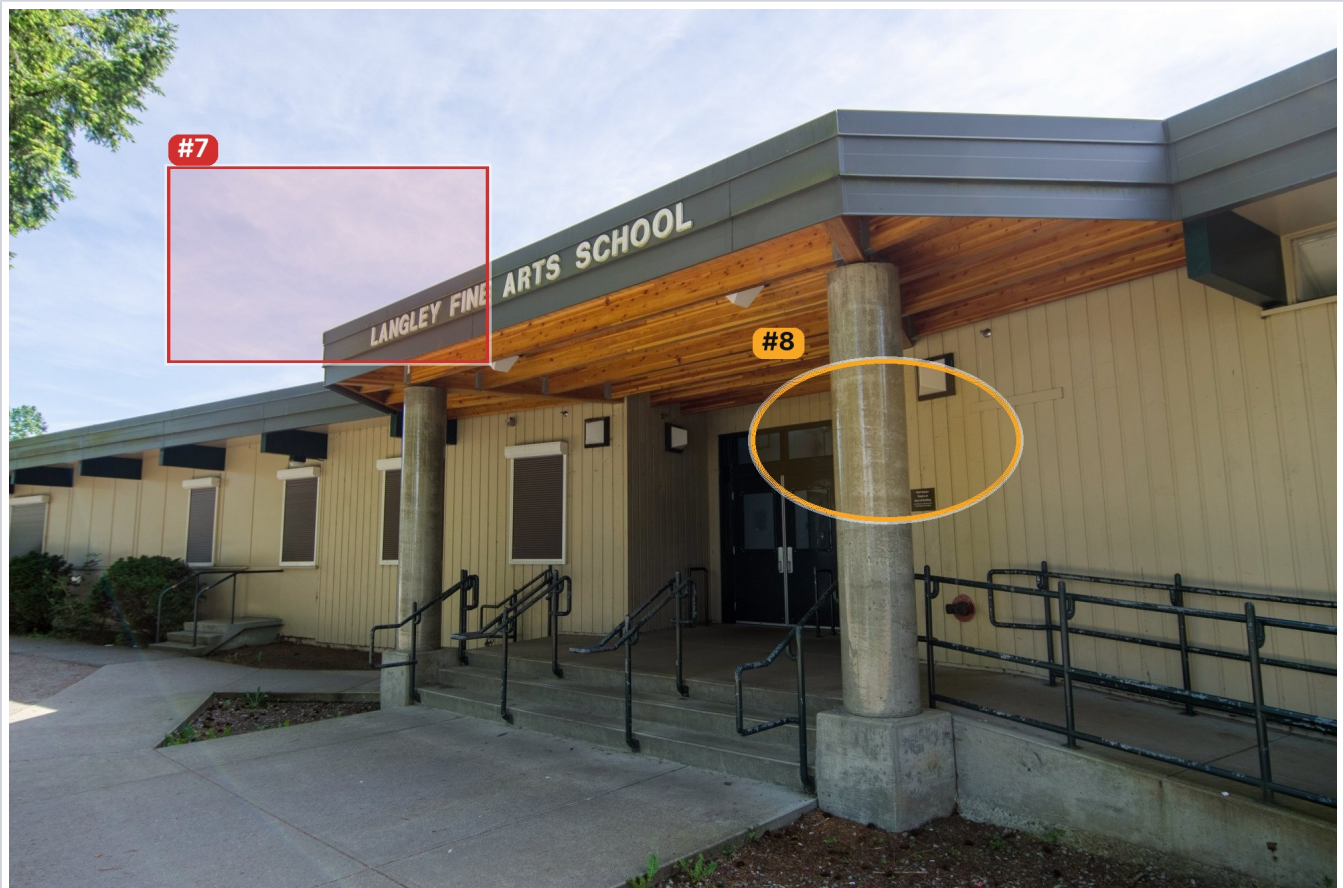
## Photograph 5 — Principal entrance (vertical)

| # | Rating | Fault type |
|---|---|---|
| #7 | A | Door opening force |
| <b>Barrier:</b> 45 N opening force on the entrance doors. <b>Effect:</b> many disabled visitors cannot open the door unaided.<br><b>Recommendation:</b> adjust the closers to 30 N or fit a power-assisted opener. | | |
| #8 | B | Loose matting |

| # | Location | Rating | Type | Summary |
|---|---|---|---|---|
| <a href="#">#7</a> | Photograph 5 — Principal entrance | A | Door opening force | Barrier: 45 N opening force on the entrance doors. Effect: many disabled visitors cannot open the door unaided. Recommendation: adjust the closers to 30 N or... |
| <a href="#">#8</a> | Photograph 5 — Principal entrance | B | Loose matting | Replace the loose coir mat with recessed matting. |

| # | Rating | Fault type |
|---|---|---|
| Replace the loose coir mat with recessed matting. | | |

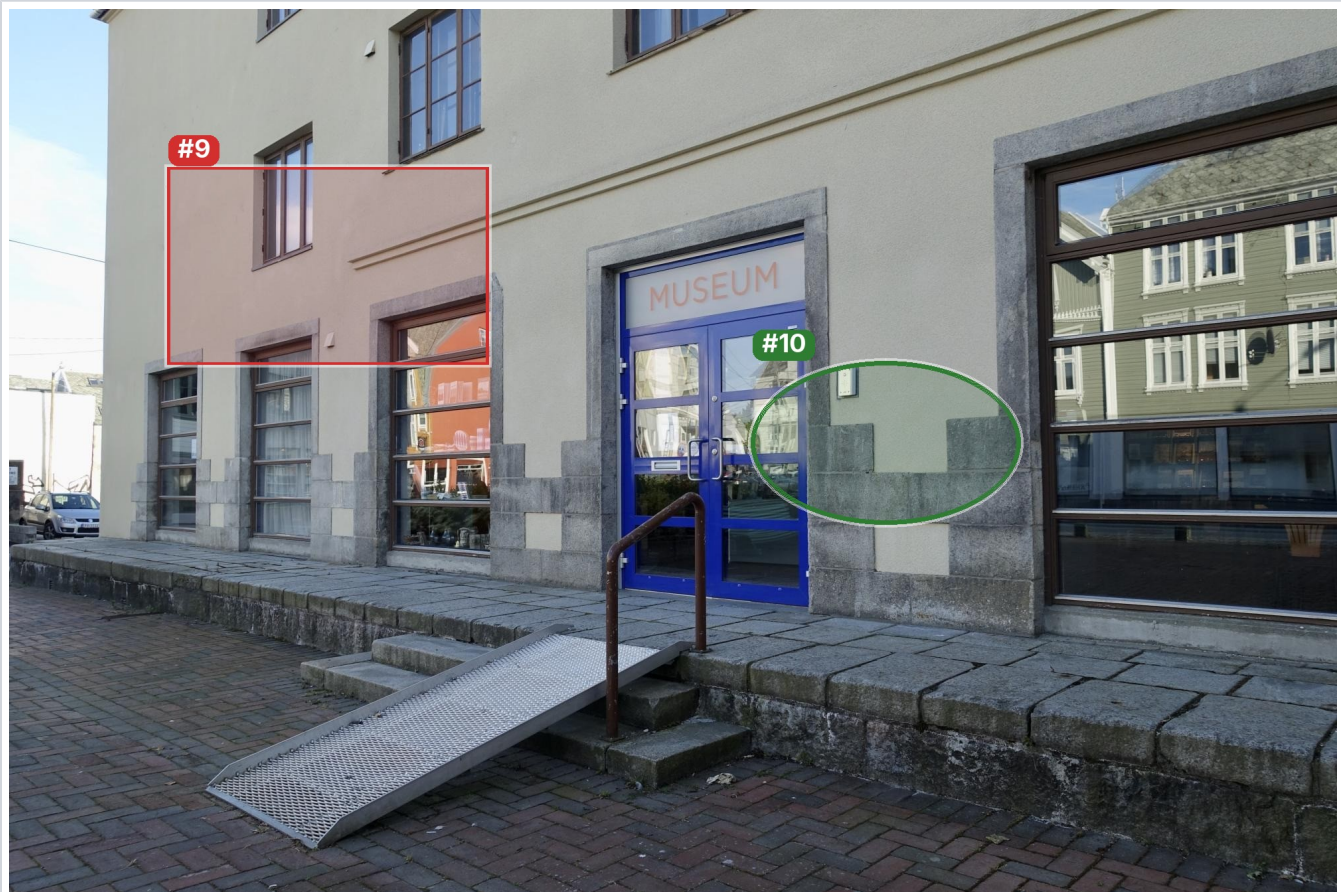
## Photograph 6 — External steps and ramp (sanitary)

| # | Rating | Fault type |
|---|---|---|
| #9 | A | Step nosings |
| <b>Barrier:</b> nosings not visually contrasted and a handrail on one side only. <b>Recommendation:</b> fit 55 mm contrasting nosings and a second handrail. | | |
| #10 | C | Obstruction |

| # | Location | Rating | Type | Summary |
|---|---|---|---|---|
| <a href="#">#9</a> | Photograph 6 — External steps and ramp | A | Step nosings | Barrier: nosings not visually contrasted and a handrail on one side only. Recommendation: fit 55 mm contrasting nosings and a second handrail. |
| <a href="#">#10</a> | Photograph 6 — External steps and ramp | C | Obstruction | Relocate the cycle stands clear of the path. |

| # | Rating | Fault type |
|---|---|---|
| Relocate the cycle stands clear of the path. | | |
