# Schedule of condition

Unit 12, Northgate Shopping Centre, Marlbury

RK-2026-0455

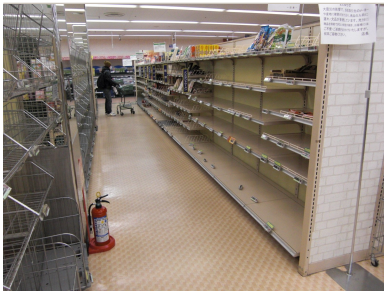
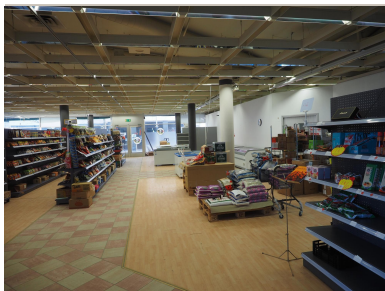
Sales area looking towards the shopfront

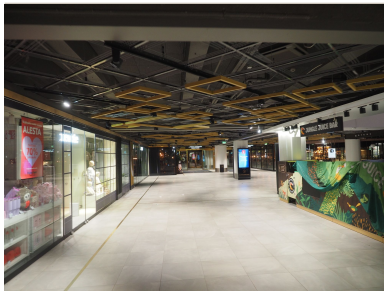
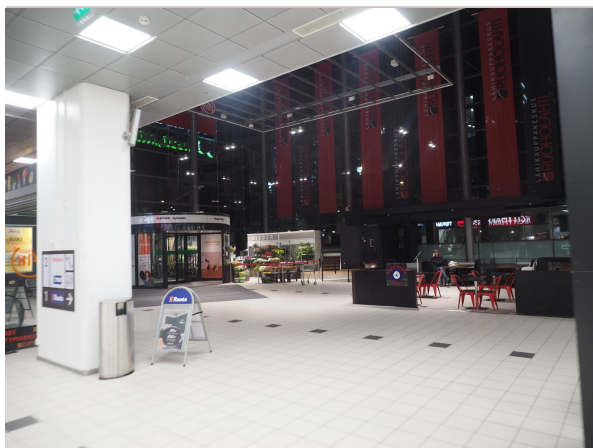
| Ref | Element | Condition / description | Rating | P |
|---|---|---|---|---|
| 1 | Shopfront glazing | Scratched toughened glass; one chipped edge. | C | |
| 2 | Fascia | Aluminium fascia with previous tenant's sign fixings; four holes. | B | |

Shopfront and fascia

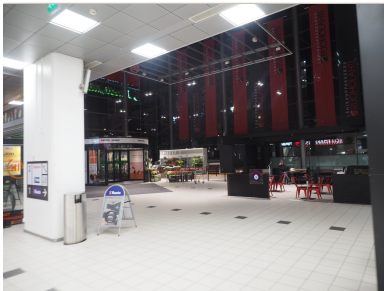
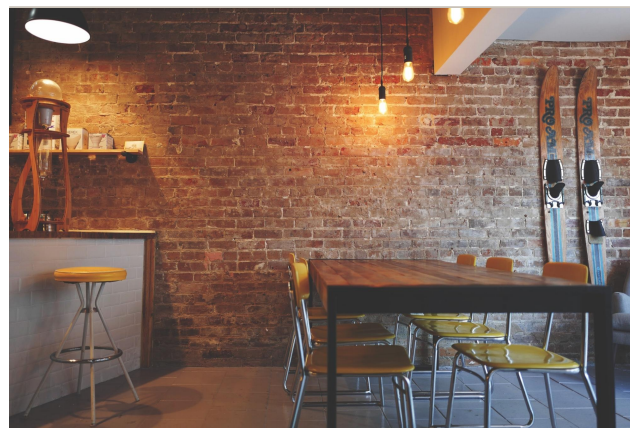
Floor finish at the entrance

| Ref | Element | Condition / description |
|---|---|---|
| 5 | Floor | Sand/cement screed with adhesive residue from the removed floor covering; |

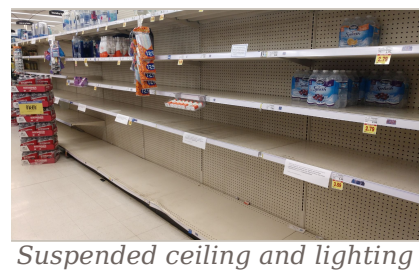
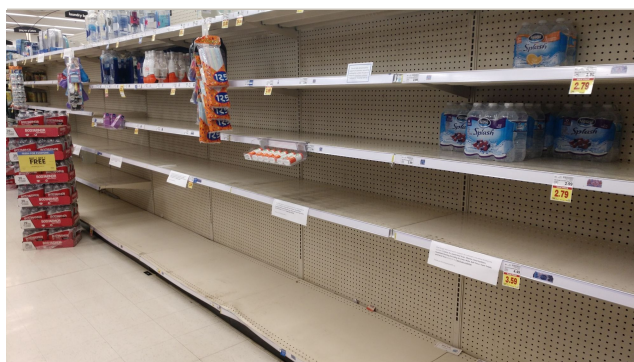
| Ref | Element | Condition / description |
|---|---|---|
| 7 | Ceiling | Suspended mineral-fibre ceiling; nine tiles missing and twelve stained. |
| 8 | Lighting | Recessed fluorescent fittings; six not working. |

Suspended ceiling and lighting
