# PV system verification report (IEC 62446-1)

Greenfold Community Energy, Riverside Business Park

| System | Riverside Building 2 roof array |
| Report reference | RK-2026-0512 |

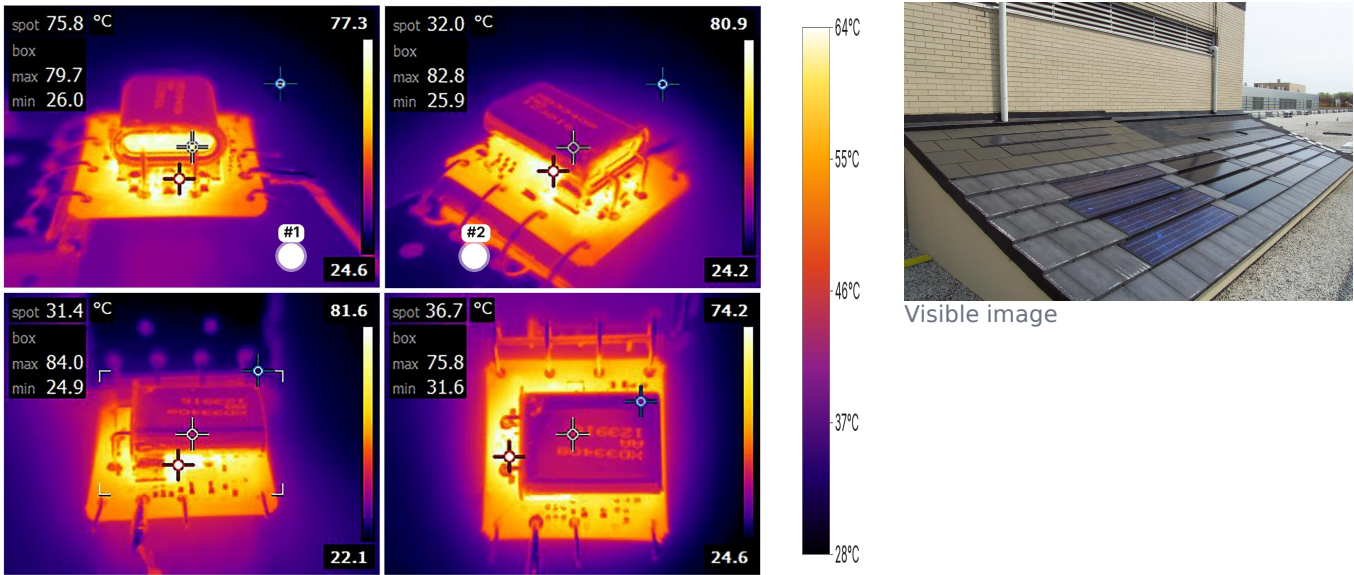
Anomaly A3

| ID | Location<br>(≥2<br>identifiers) | Abnormality | CoA | T<br>max<br>(°C) | T ref<br>(°C) | ΔT (K) | G<br>(W/m²) | x | ΔT at<br>1000<br>W/m²<br>(K) | Module<br>Wp | Est.<br>loss<br>(%) | Est.<br>kWh/yr | Est.<br>£/yr | Remedial<br>action |
|---|---|---|---|---|---|---|---|---|---|---|---|---|---|---|
| A3 | Combiner<br>box CB-2 | Heated<br>connection,<br>string 4<br>fuse holder | CoA<br>3 | 61.4 | 33.5 | 4.9 | 812 | 1.00 | #REF! | 7,380 | 1.0 | 7 | #REF! | Isolate and<br>remake the<br>connection<br>immediately |

String 4 fuse holder 28 K hotter than its neighbours under the same load: a high-resistance connection. Classified CoA 3 (fire risk); rectified on site and re-imaged.

Combiner box CB-2, string 4 fuse holder, 28 K above the neighbouring holders at 61 °C. This is a loose or corroded connection and is classified CoA 3 because of the fire risk. The connection was isolated and remade on the day; a repeat image after 30 minutes showed the holder within 2 K of its neighbours. Recommend checking torque on all fuse holders in CB-1 and CB-2 and repeating the thermography in two years.
