# Structural inspection report

Former mill warehouse, Weir Street, Calder Vale

RK-2026-0498

| Report type | Defect investigation |

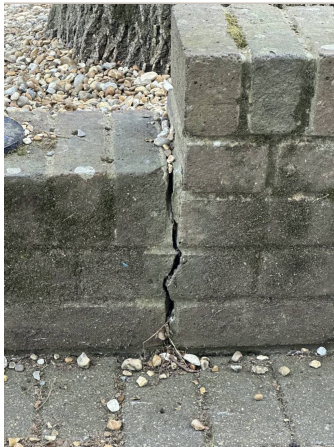
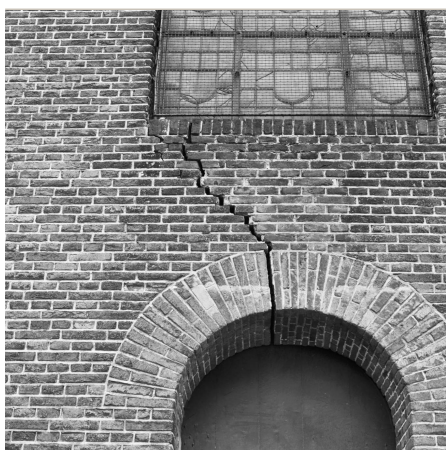
*North elevation showing the stepped crack at grid C*

| Ref | Element | Location | Condition / description | Cause | Rating | Photo | Measurement | Recommended action | Timescale |
|---|---|---|---|---|---|---|---|---|---|
| 1 | North wall | Grid C, window N3 to parapet | Stepped crack C1, 2 mm to 6 mm, tapering wider at the top. | Differential settlement over the culvert | 3 | | 6 mm | Monitor; trial pits; underpin and stitch | 1 to 6 months |

The crack pattern (stepped, tapering, wider at the top, located over the culvert) is characteristic of differential settlement at the north-west corner rather than thermal movement or lintel failure. The reactivation in winter is consistent with softening of the clay by leakage from the culvert, which is partly blocked and overflowing at the inlet. Category 3 damage is serviceability rather than stability, but continued movement could affect the stability of the parapet and the window heads. Corrosion of the wall ties at the parapet is a separate, age-related defect.

Immediate: fence off the pavement below the parapet at grid C and remove the loose coping. Within one month: CCTV survey of the culvert and clear the inlet; install three tell-tales and take monthly readings for six months. Within three months: two trial pits at grid C to confirm the foundation and soil. Before conversion: subject to monitoring, local underpinning at grids B to D (about 9 m), helical-bar stitching of cracks C1 and C2, replacement of the parapet ties and repointing. A structural engineer should review the monitoring results before the conversion design is finalised.

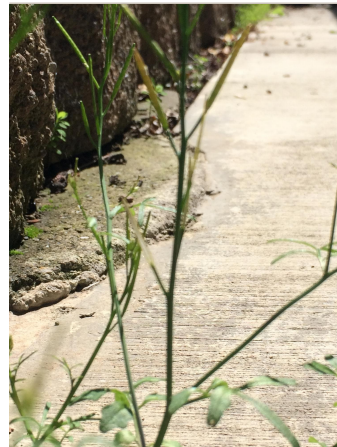
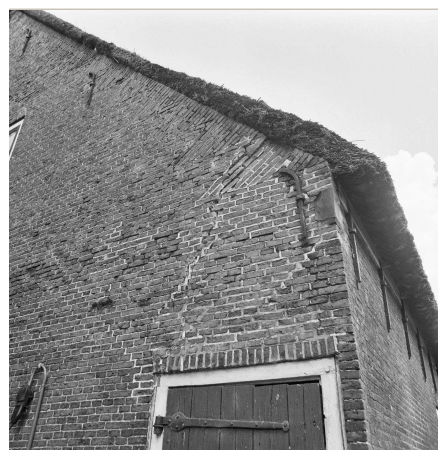
*Crack C1 with tell-tale installed*

| Tell-tale /<br>stud ref | Location | Installed | Baseline<br>(mm) | Reading 1<br>(date / mm) | Reading 2<br>(date / mm) | Net change<br>(mm) |
|---|---|---|---|---|---|---|
| TT1 | C1 at parapet | 2026-04-22 | 6 | | | |

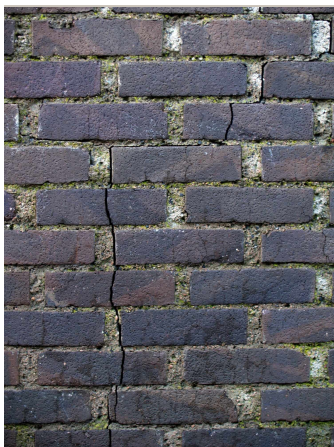
*Diagonal cracking above the ground-floor window, grid D*

| Ref | Element | Location | Condition / description | Cause | Rating | Photo | Measurement | Recommended action | Timescale |
|---|---|---|---|---|---|---|---|---|---|
| 2 | North wall | Grid D, above window N4 | Diagonal crack C2, 2 mm. | Settlement; old arch repair | 2 | | 2 mm | Monitor; stitch with C1 | 6 months |

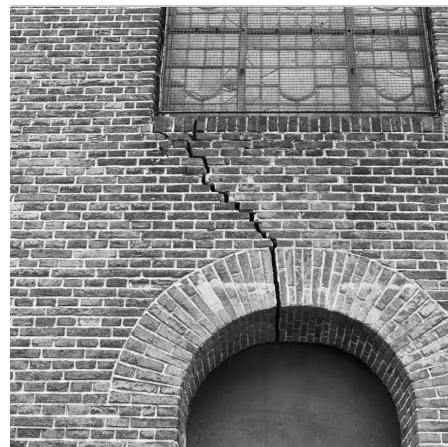
*Corroded wall tie exposed at the parapet*

| Ref | Element | Location | Condition / description | Cause | Rating | Photo | Measurement | Recommended action | Timescale |
|---|---|---|---|---|---|---|---|---|---|
| 3 | Parapet | Grid C | Coping displaced 10 mm; wall tie corroded through. | Movement; corrosion | 4 | | 10 mm | Fence off; remove loose coping; replace ties | Immediate |

| Ref | Further investigation / action | Why | When | By whom |
|---|---|---|---|---|
| R1 | Fence off the pavement and remove the loose coping | Falling masonry risk | Immediate | Client |
