# Investigation of pressure loss in the LTHW heating circuit

Calder Vale Community Centre

RK-2026-0446

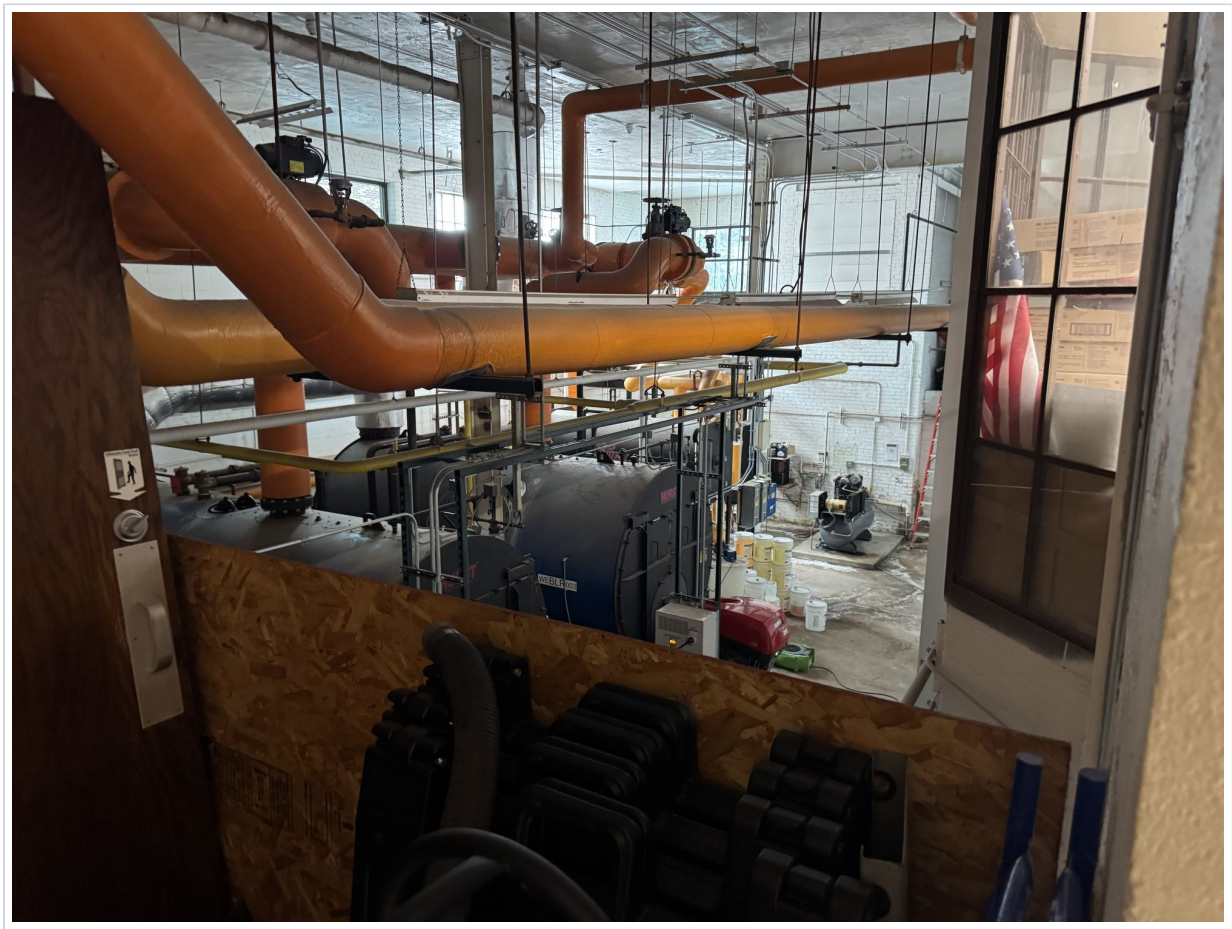
The cold pressure was 0.6 bar on arrival. The isolated system lost 0.35 bar over 24 hours on both test days. The expansion vessel pre-charge was 0.2 bar against a nominal 1.0 bar and water was present at the air valve, indicating a failed diaphragm. A compression joint on the 28 mm return below the low-loss header was weeping, with scale and corrosion deposits on the floor beneath. The automatic air vents were passing air. No damp or staining was found in the ceiling voids or at the floor-mounted fan convectors.

**Figure 3.1** — *Figure 1: weeping compression joint below the low-loss header*

The measured loss (table 1) is consistent with a small continuous leak; the make-up volume of 41 litres per week equates to about 6 litres per day, matching the weeping joint. The failed expansion vessel means that normal thermal expansion now discharges through the pressure relief valve during each heating cycle, which accounts for the larger pressure swings reported by the caretaker and for the lockouts occurring after the boilers cool.

The pressure loss has two causes: a weeping compression joint below the low-loss header and a failed expansion vessel diaphragm. Neither is serious in itself, but together they cause the boilers to lock out on low pressure. There is no evidence of a concealed leak in the floor or ceiling voids.

R1: remake the weeping joint with a new olive and re-dose the system with inhibitor (heating contractor, within two weeks). R2: replace the expansion vessel with a 50-litre vessel pre-charged to 1.0 bar (within two weeks). R3: fit a permanent water meter on the filling loop and log it weekly (caretaker, within one month). R4: if make-up exceeds 5 litres per month after the repairs, carry out a tracer-gas test of the underfloor pipework.

| Ref | Recommendation | Priority | Owner | By when |
|---|---|---|---|---|
| R1 | Remake the weeping joint below the low-loss header and re-dose inhibitor | High | Heating contractor | 2026-04-21 |
