# Drone roof inspection report

## Tillerman Logistics distribution centre, Ridgeway Industrial Estate

| Reference | RK-2026-0433 |
| Survey date | 26 Mar 2026 |

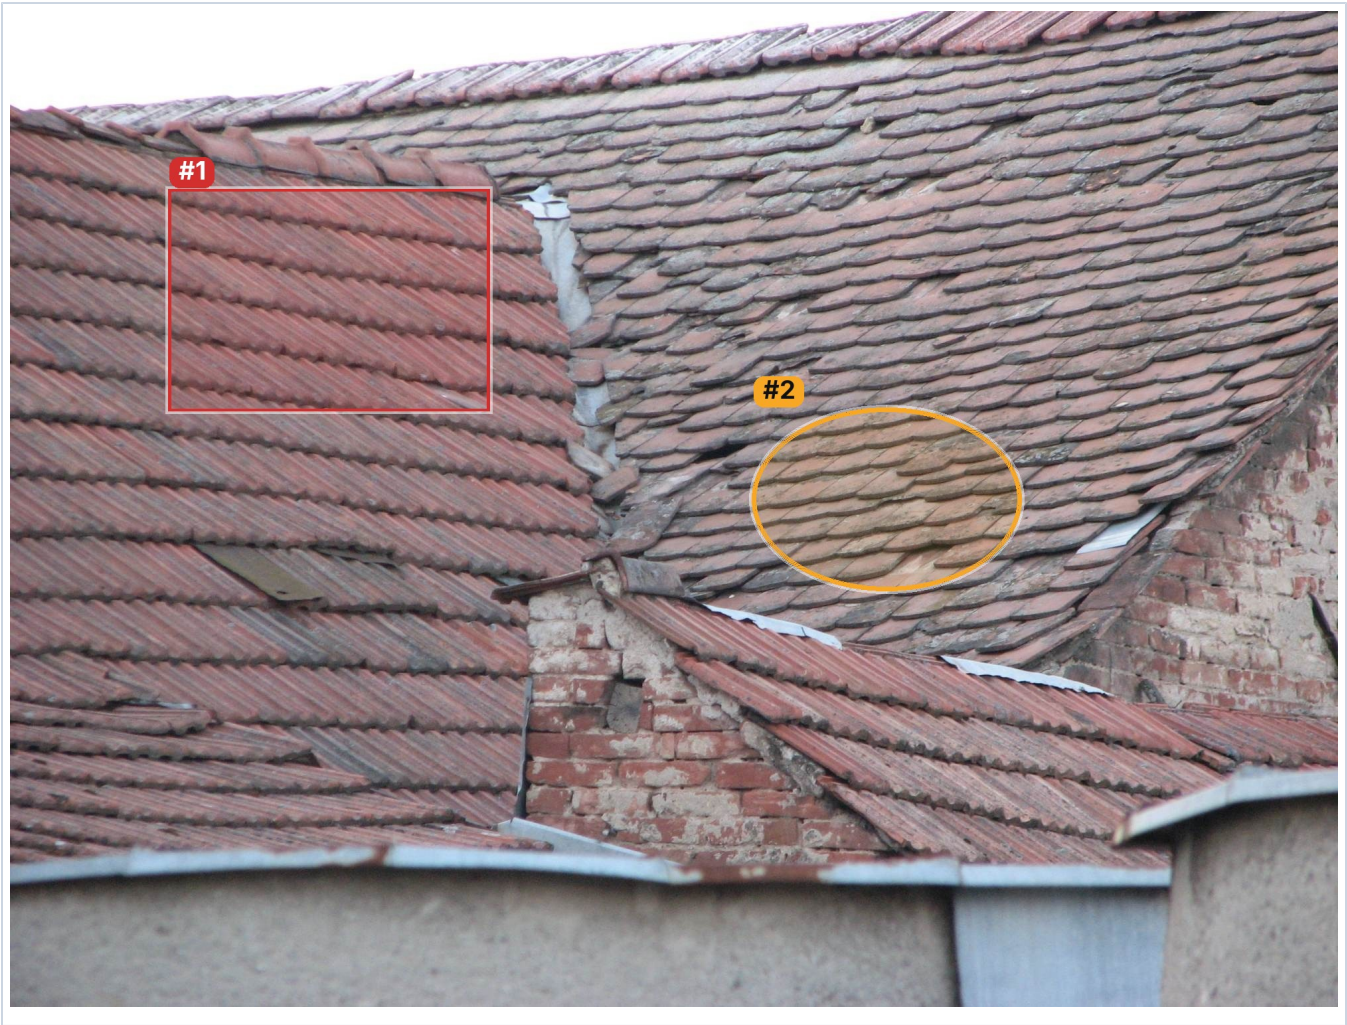
Photograph 1 — Ridge capping at gridline 7 (Main roof)

| Ref | Element | Location | Condition / description | Rating | Photo | Measurement | Recommended action | Timescale |
|---|---|---|---|---|---|---|---|---|
| 1 | Ridge capping | Gridline 7, main roof | Capping displaced 300 mm; fixings missing. | Red | | | Refix with new stitching screws; check adjacent cappings | Within 1 month |

| # | Rating | Detail | Fault type | Tags |
|---|---|---|---|---|
| #1 | Red | | Displaced capping | Wind damage Fixings issue |
| <b>Defect:</b> ridge capping displaced about 300 mm with missing fixings. <b>Risk:</b> water ingress and further wind damage; the loose capping could fall. <b>Recommendation:</b> refix with new stitching screws and check the remaining cappings within one month. | | | | |
| #2 | Amber | | Cut-edge corrosion | Cut end corrosion |
| Edge corrosion to the adjacent sheet; treat with a cut-edge coating in the next maintenance window. | | | | |

1. Refix the ridge capping at gridline 7 and check the remaining cappings (roofing contractor, within one month). 2. Clear the valley gutter outlets and fit leaf guards (within one month). 3. Replace the cracked roof-light and fit fragile-roof signage at the access ladder (within one month). 4. Programme the amber items (sealant renewal, cut-edge corrosion treatment, gutter joint repairs) for the summer maintenance window. 5. Re-survey in 24 months or after any storm event.
